SB326/CC5551: Exterior Elevated Elements (EEE)
(Associated Waterproofing Systems / Load-Bearing Components)
Building Assessment Report
July 1, 2022

Farm Hills Heights
(RSM 88/12-17)
4050–4062–4074–4086 Farm Hill Boulevard
Redwood City, California

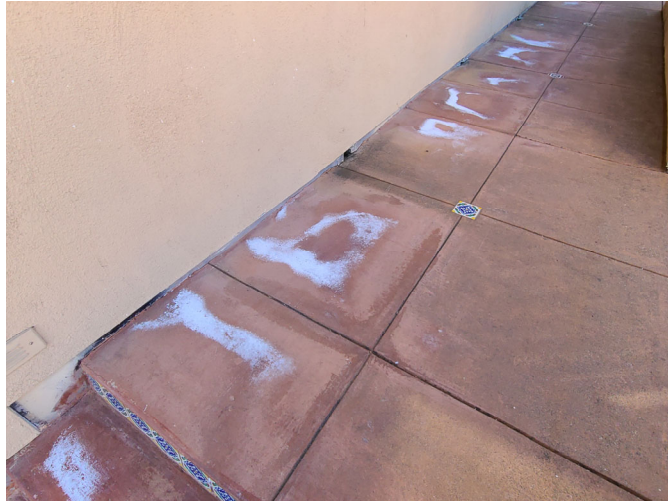
4050 Concrete Efflorescence

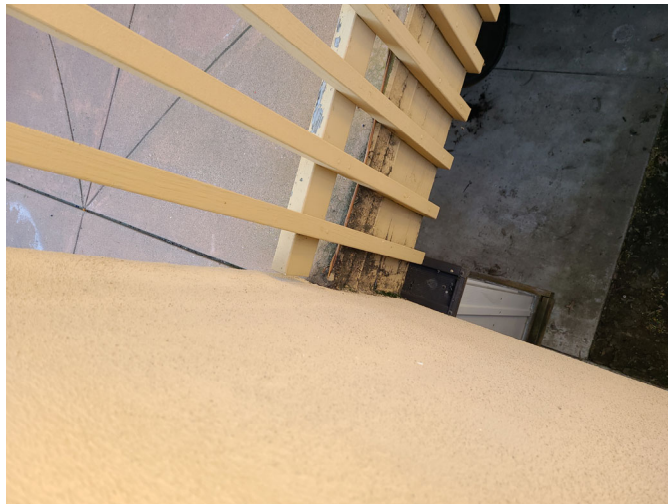
Bridgeway Rim Dryrot

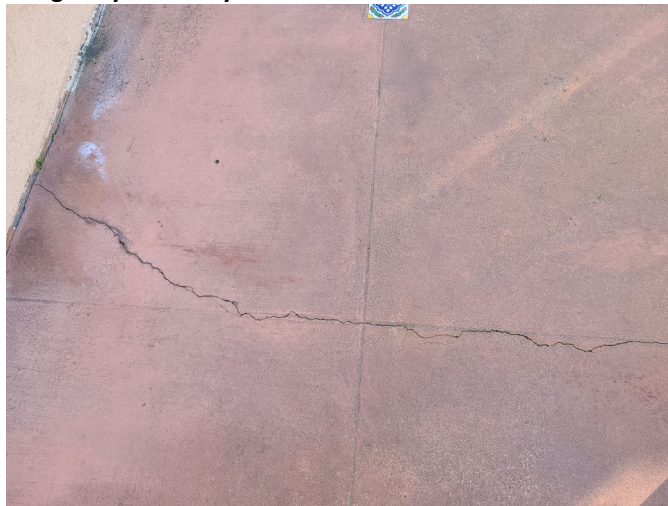
Bridgeway Concrete Deck Cracking

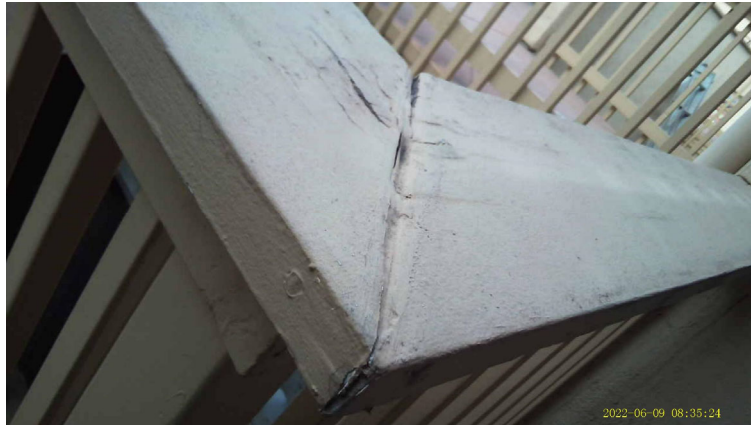
4050 #1: Handrail Dryrot

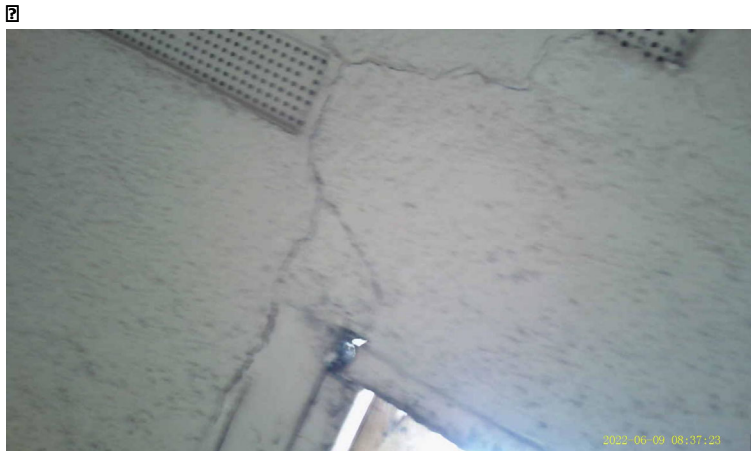
4050 #2: Stucco Soffit Cracking

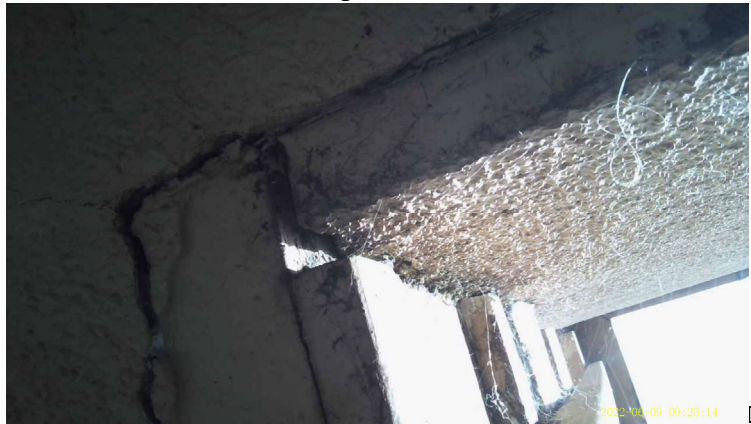
4050 #3: Deck Flashing Failure Dryrot

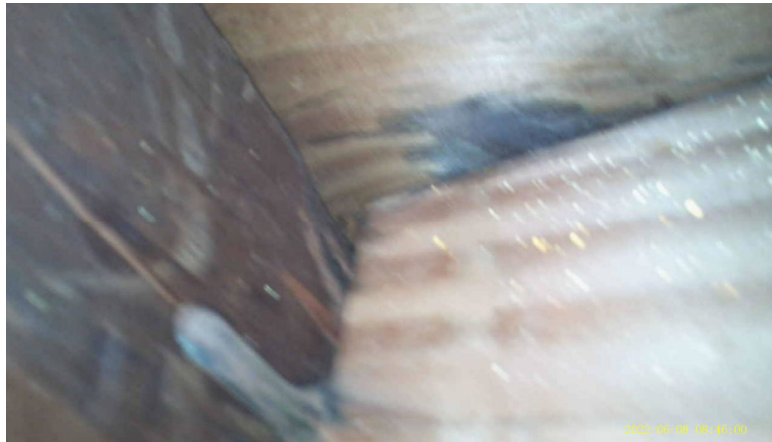
4062#2: Stained plywood & joist

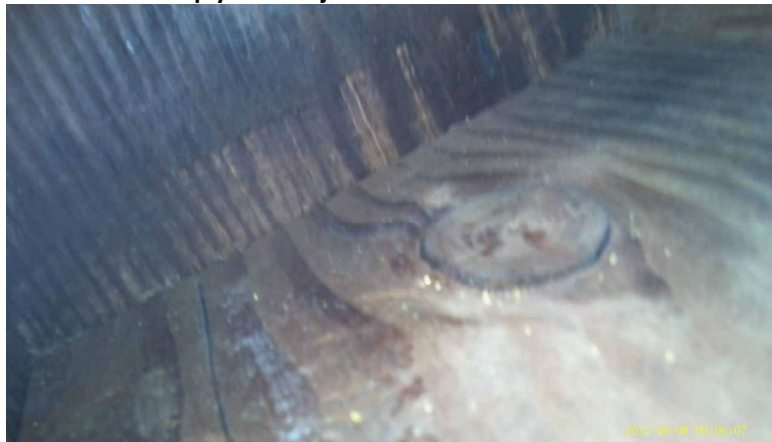
4062#3: Stained plywood & joist

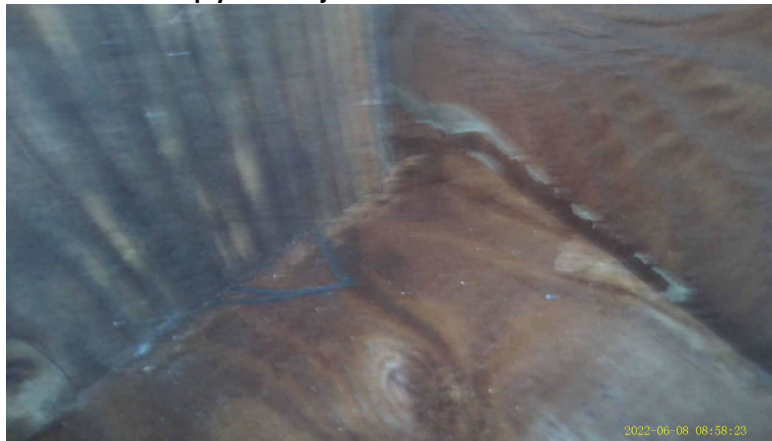
4062#4: Stained plywood & joist

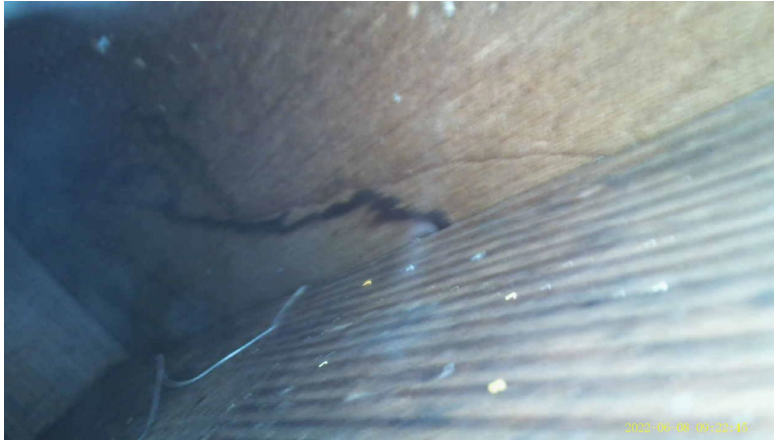
4062#5: Stained plywood & joist

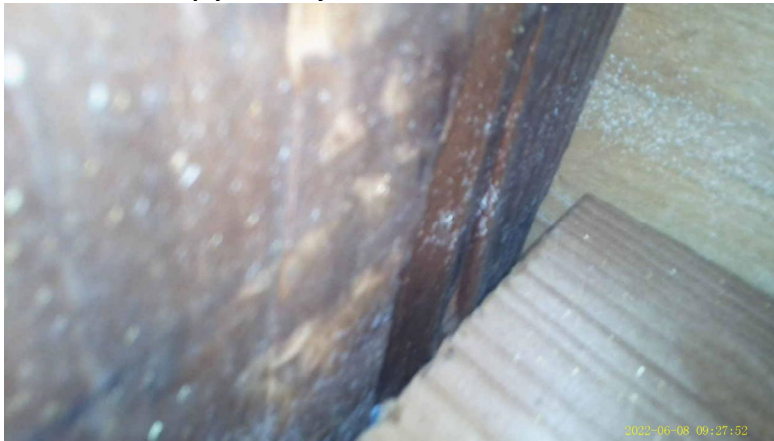
4062#7: Stained plywood & joist

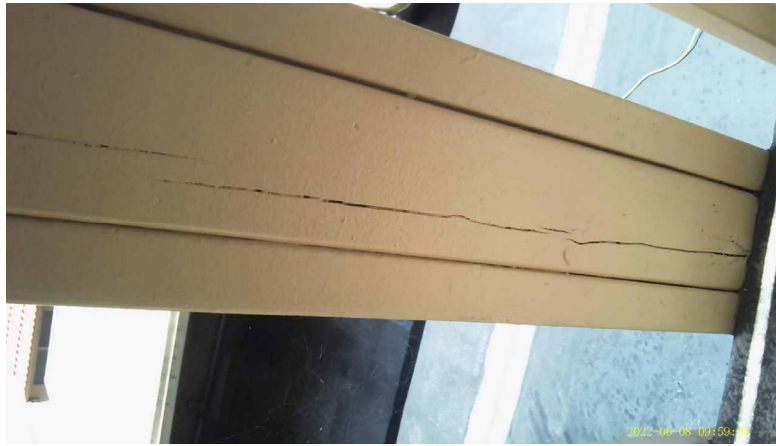
4062 #8	2nd Flr Balcony	Rear	1C, 1D	Dryrot around posts, stucco cracking and handrail dryrot noted

4062 #8: Checked Column

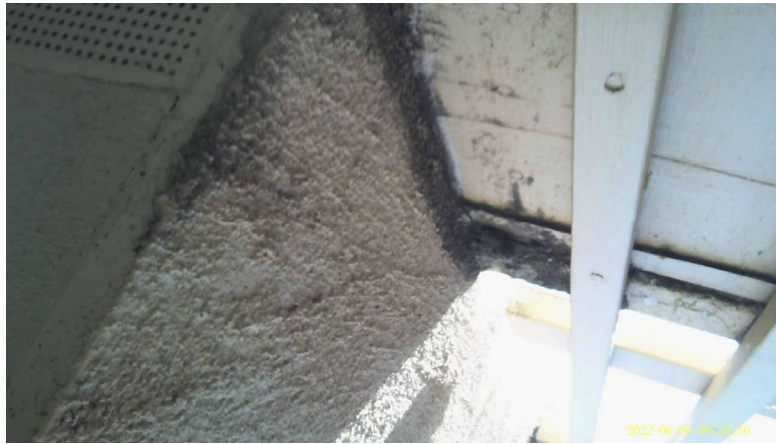
4074 #2: Rim Moist with Dryrot

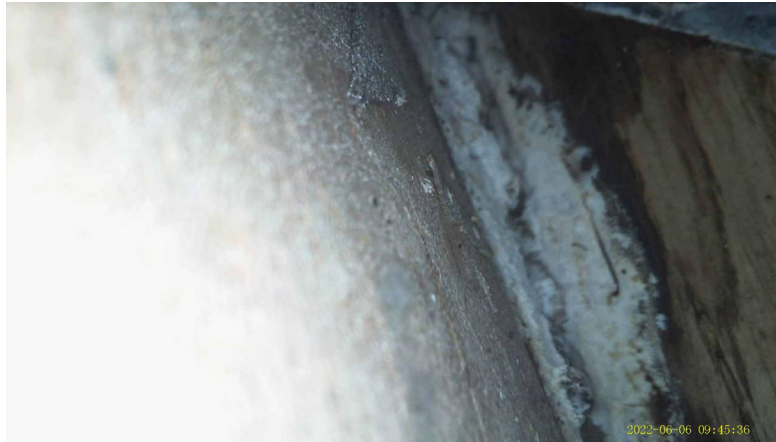
4072 #3: Dryrot within Joist Bay

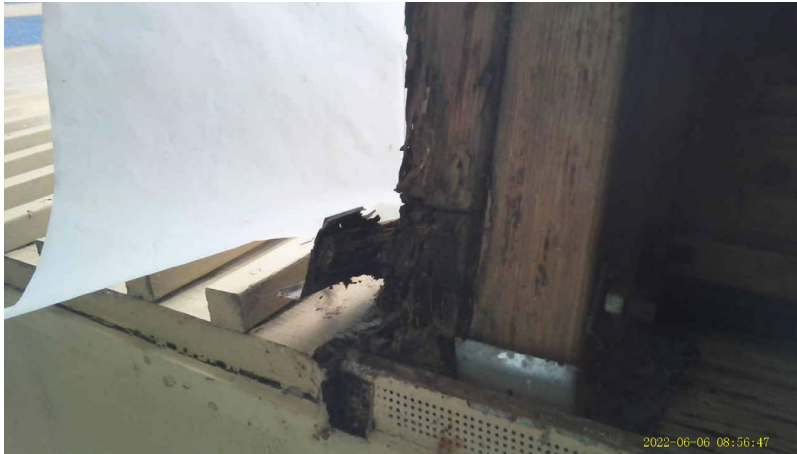
4074 #1: Trim moisture rot

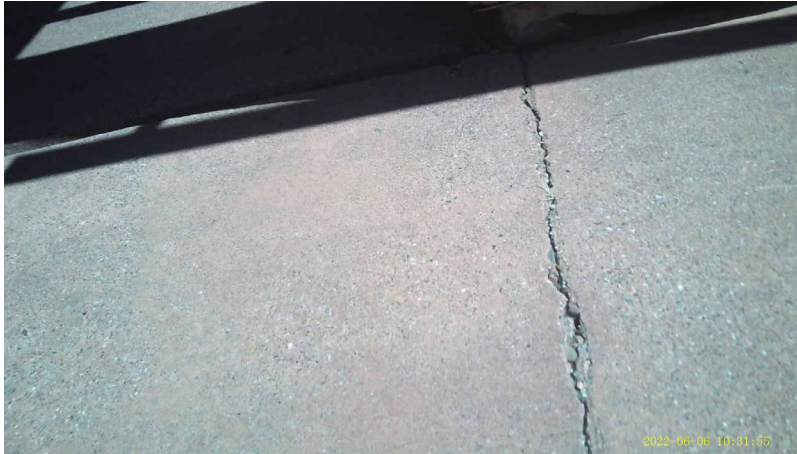
4074 #4: Concrete cracking tracking stained plywood moisture

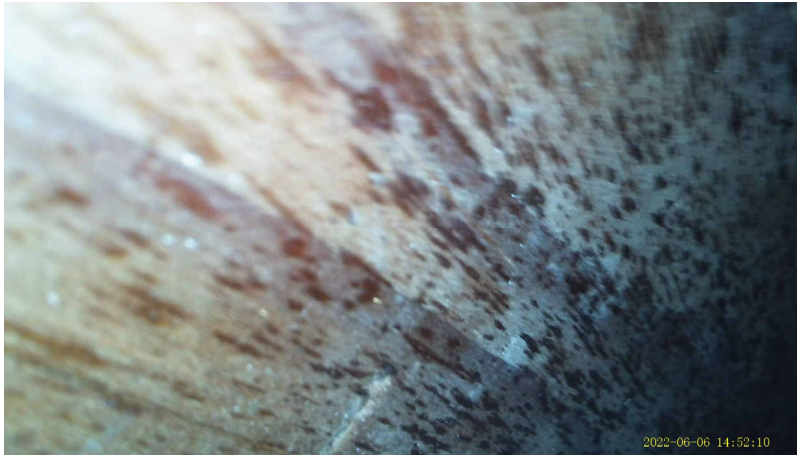
4074 #5: Stained plywood moisture

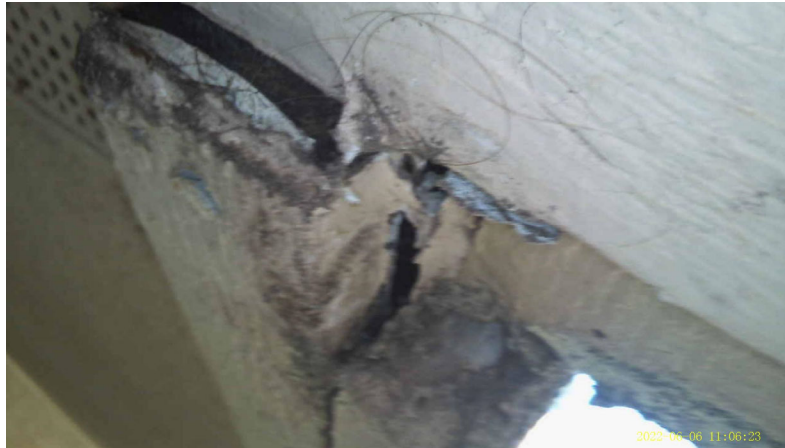
4074#6: Dryrot wood trim

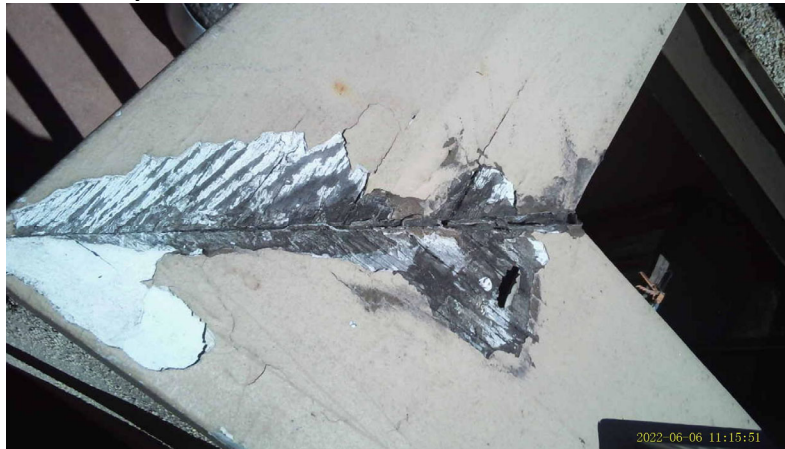
4074#7: Top rail dryrot

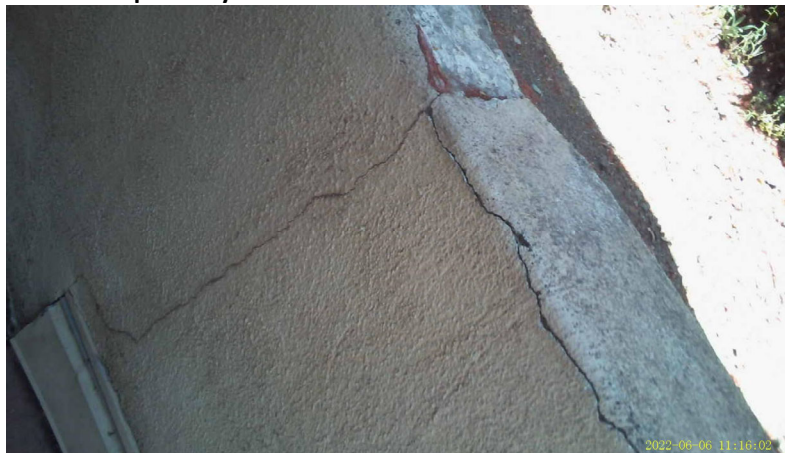
4074#7: Wall top cap stucco spalling

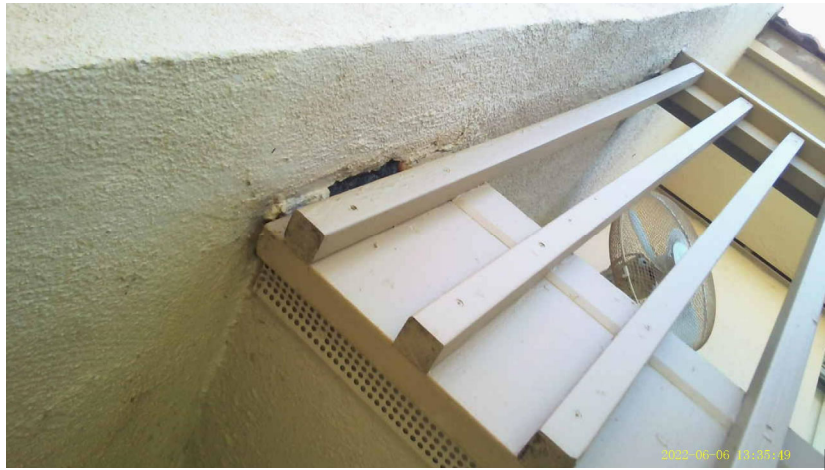
4086#6: Exposed wall framing building wrap
